Preliminary Reuse Assessment

Pownal Tannery Superfund Site

Office of Site Remediation and Restoration
September 2002

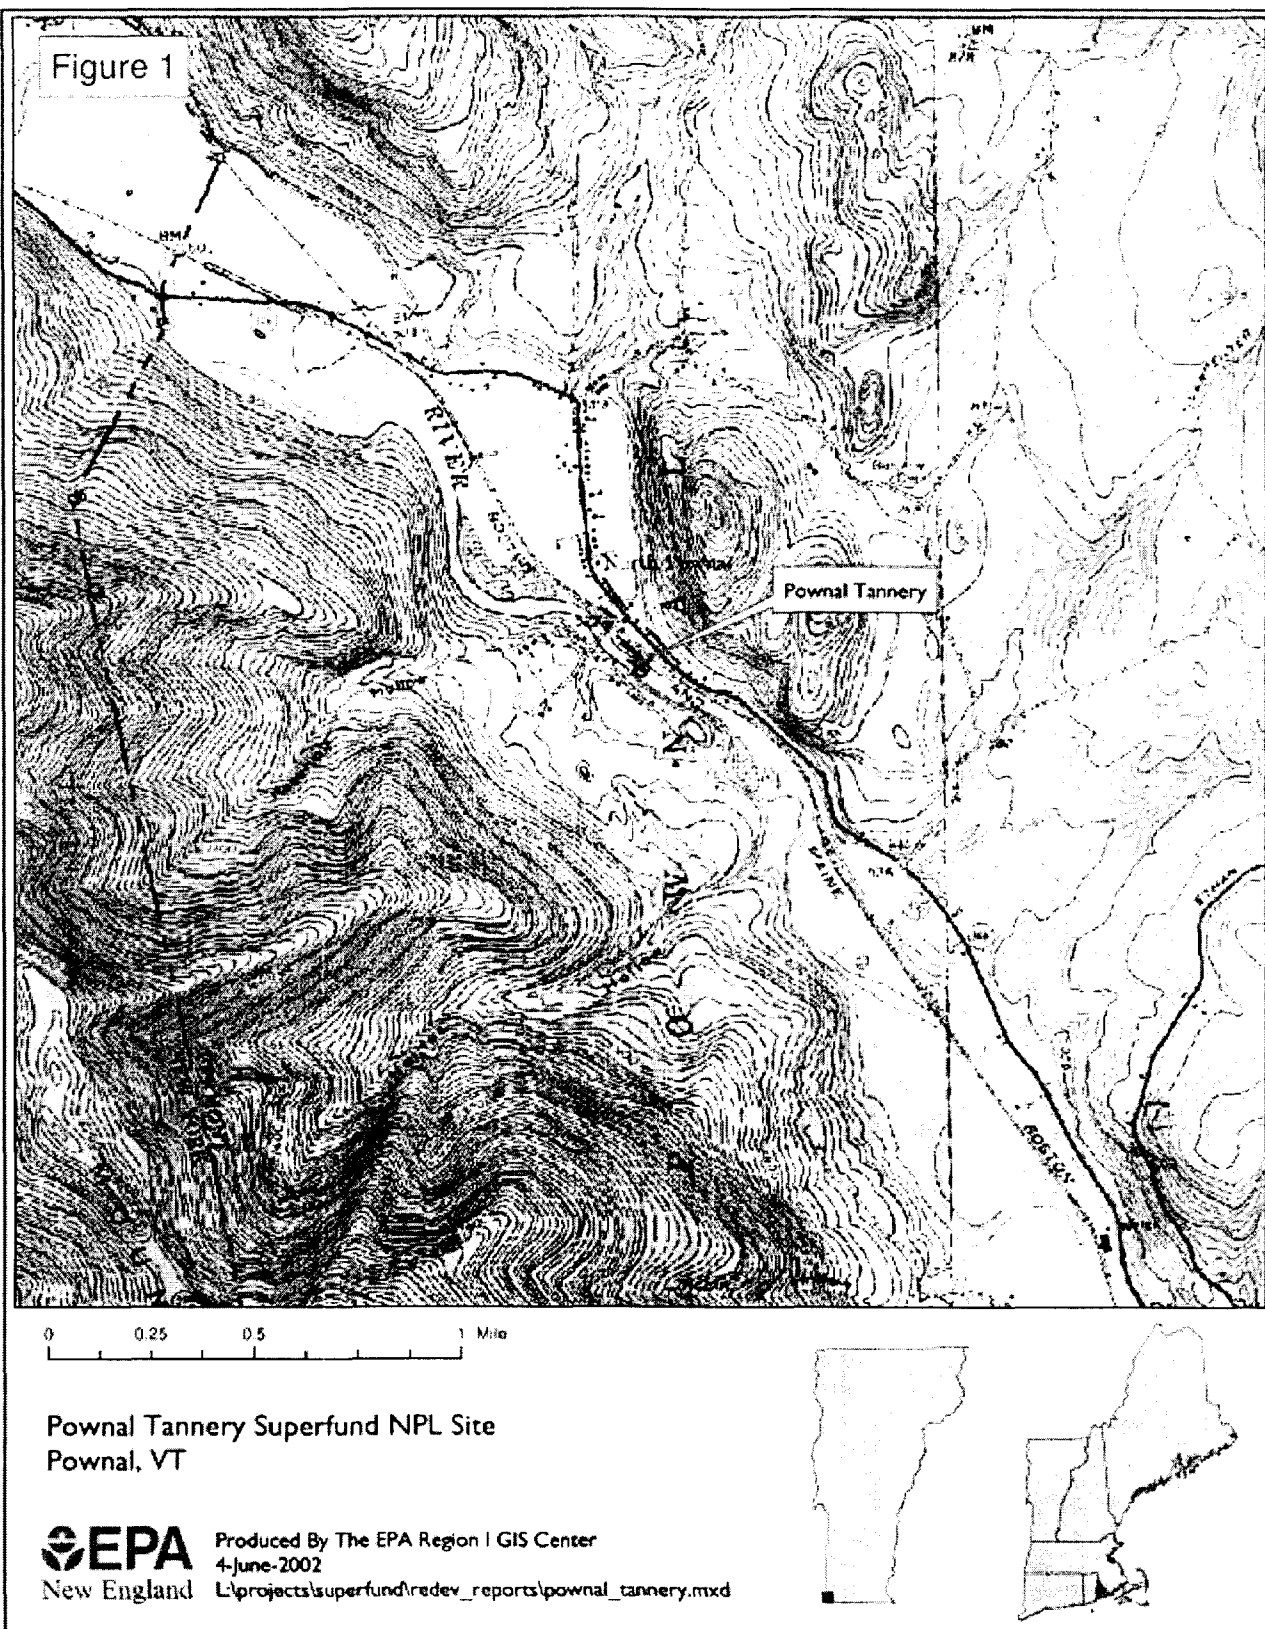
► Fig. 1

The Pownal Tannery Superfund site is located between Route 347 and the Hoosic River in the village of North Pownal, in Bennington County, Vermont (see figure 1). The site was a former hide tanning and finishing facility owned by the Pownal Tanning Company, Inc. The site has been inactive since 1988, when the company declared bankruptcy. The site consists of three contamination sources: the tannery building complex, a lagoon system, and the tannery's sludge landfill. In total, the Pownal Tannery site encompasses approximately 28 acres.

Location: State Route 346
Pownal, Vermont
(Bennington County)
42° 47' 49.8" north latitude
73°15' 56.7" west longitude
(See Figures 1 & 2)

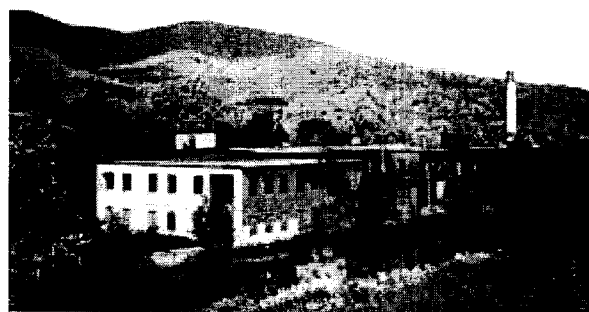
Pownal Tannery building prior to demolition

The former tannery building occupied approximately 170,000 square feet. The original northern and central portion of the building was primarily of brick construction with a partially earthen floor. The building was four stories tall including the basement. Prior to the beginning of the Remedial Investigation, the Tannery Building was decontaminated and demolished by the United States Army Corps of Engineers (USACE) for EPA as part of the NTCRA. In addition, a large volume of soil was excavated from inside the building footprint, all known underground piping was removed, and several underground manways were filled and closed. Portions of the original building foundations remain underground in some places, and the entire site was regraded and finished with grass, crushed rock and stone. As a result of the USACE actions taken on this portion of the site, all potential contaminant source areas were addressed.

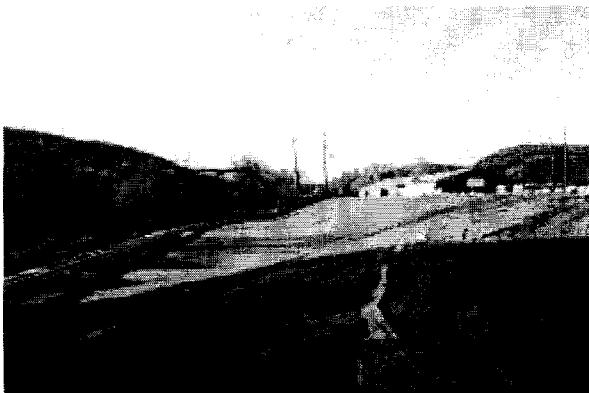
Tannery building area after demolition, warehouse building is visible in the background of photo

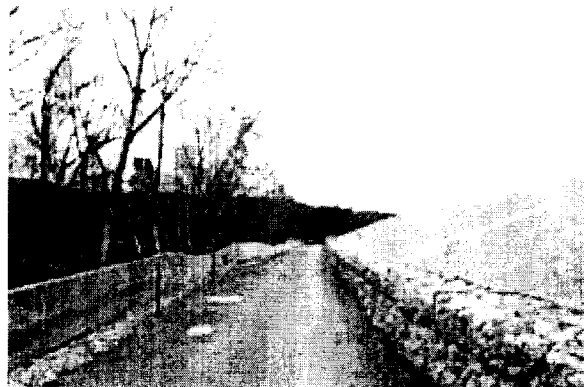
Landfill area showing cap completed by EPA in 2001

Current and Potential Future Uses: The landfill was capped as part of EPA's NTCRA, completed in 2001. The landfill area was not evaluated as part of FA&A's February 2001 Reuse Assessment. The town has no plans to take title to this property. Operation and maintenance activities to preserve the landfill's current condition is being addressed by the Vermont Department of Environmental Conservation (DEC)
